# LG Optimus Exceed 2 Rear Camera Replacement

The removal of the stock Rear facing camera on an LG Optimus Exceed 2.

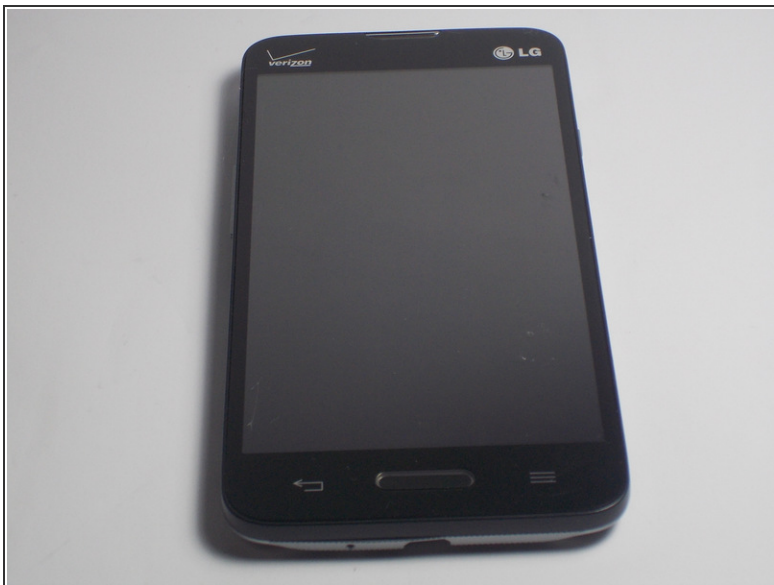
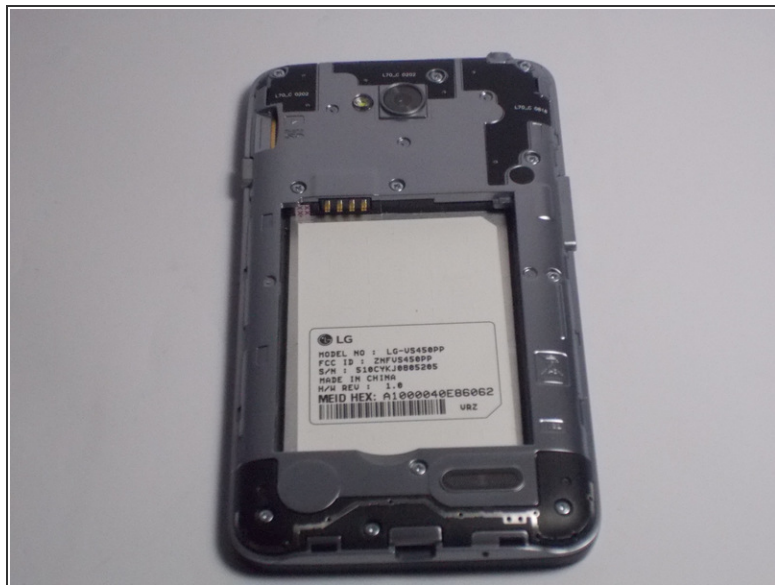
## Step 1 — Battery

- Flip the device over and remove the back covering.

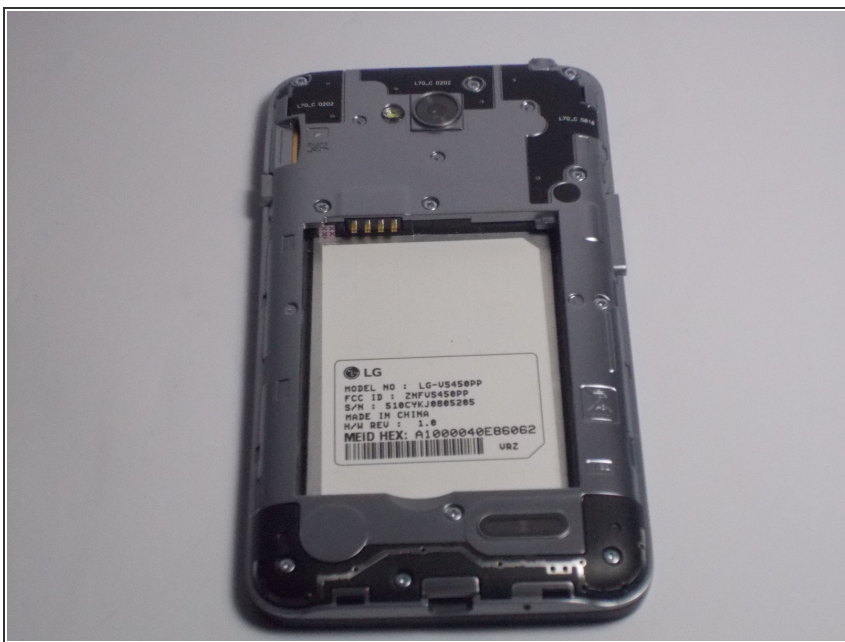
## Step 2

- Push on the top of the battery downward and pull the battery off of the device.

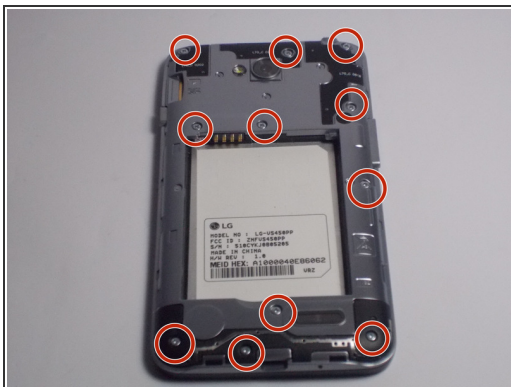
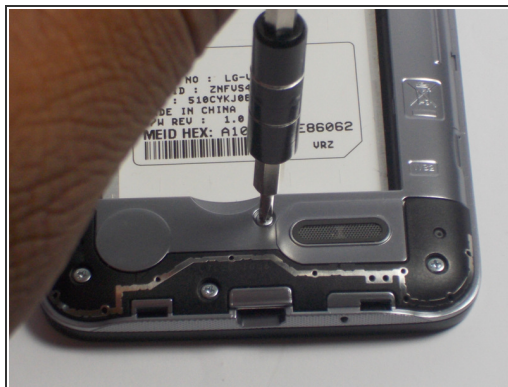
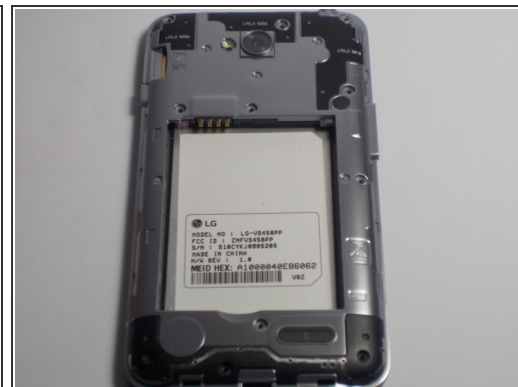
## Step 3 — Rear Camera

- Remove the eleven 4mm screws using a Philips head screw driver.

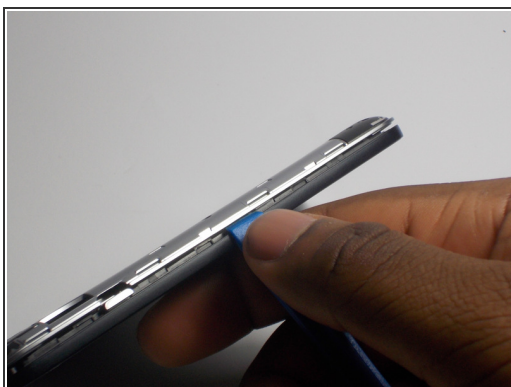
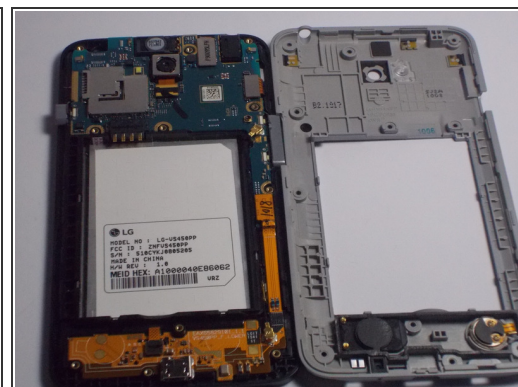
## Step 4

- Insert the plastic opening tool into the side of the device and pry off silver covering. Push up against the back covering when the tool is inserted to detach from the phone.
- i** Make sure to detach all sides of silver covering before lifting it off the phone.
